**Volume 10: SUMMER 2008**
**IN THIS ISSUE . . .**

Architectnics is the architectural technology journal of McGinnis Chen Associates, Inc.

**A RECONSTRUCTION OF ELEVATED ENTRY WALKWAYS**

A Case Study  
by Majid Azadeh, PE

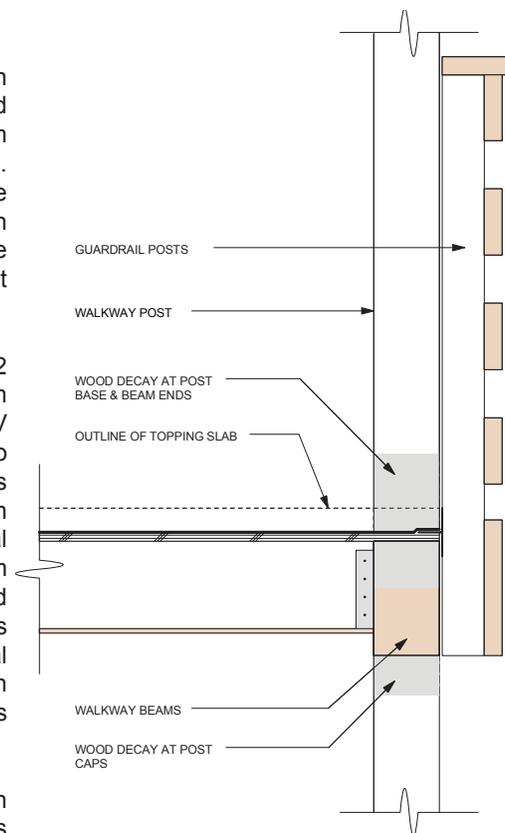
*Original Elevated Walkway*

The existing walkways and stairs were constructed of heavy timber post and beam framing of untreated Douglas Fir. End grains were exposed to weather at column tops and beam ends. Guardrail posts and railings were also fabricated from untreated Douglas Fir framing elements. All exposed framing elements were painted after construction with no application of primer at concealed joints.

The walkways were paved with a concrete topping slab cast over self-adhered sheet membrane applied directly over the plywood sub-floor. The existing membrane was punctuated by numerous post penetrations with inadequate and/or maintenance intensive flashing. Membrane delamination and waterproofing discontinuities were noted at nearly all penetrations and terminations. Lack of adequate drainage further exacerbated the overall distress to the structural elements.

Membrane flashing failures had occurred at nearly all post penetrations, resulting in severe deterioration of posts, beams and plywood sub-floors. Further deterioration of post bases had occurred at connections to podium slabs. Wood decay was also noted at the concealed joints between top rails and caps of the guardrails.

The final remedial approach was conceived with foremost considerations for waterproofing and durability. Post locations were shifted beyond the walkway edges, eliminating all membrane penetrations, and allowing uninterrupted sheet drainage for runoff. The new

continuous posts were shop fabricated from structural tube steel with welded brackets and base plates. New posts were fastened to the sides of the walkway beams, reducing shoring requirements and facilitating continuous use of dwellings during construction. To avoid cutting the reinforcing steel, the podium slab was x-rayed at base-plate locations to allow for anchor bolt installation. New guardrails were fabricated from steel channels, and were also side mounted for enhanced drainage. Steel posts were coated with intumescent fireproofing. All exposed framing lumber - including guardrail runners and walkway beams - were specified of naturally durable or preservative-treated species. All fasteners were specified to be stainless steel.

Walkway sub-floors were coated with a fluid-applied membrane, ensuring adequate coverage and adhesion to wood and metal substrates. Sheet membrane was used extensively to protect the exterior face of walkway beams. Caulking was used at all fastener penetrations. All waterproofing materials were single-sourced to eliminate potential compatibility issues. The walkway assembly was paved with a light-weight concrete topping slab to protect the membrane and provide a pedestrian traffic bearing surface.
