Architectnics

A JOURNAL OF ARCHITECTURAL TECHNOLOGY

Volume 8: SPRING 2007

THE EARL WARREN STATE BUILDING A Case Study

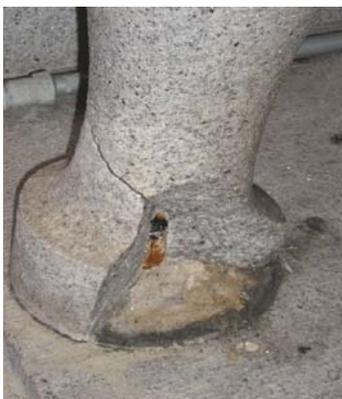
(E) Cracked base at baluster
Note rusting steel dowel

At one baluster, a one-pound piece was easily removed just below the rail. The removal revealed a one-half inch diameter steel rod embedded into the baluster. Extensive corrosion was observed. It was apparent that the balusters were cracking due to the corrosion and associated expansion of the steel rod anchors, a condition commonly referred to as "rust jacking."
